The *Normal* Hole

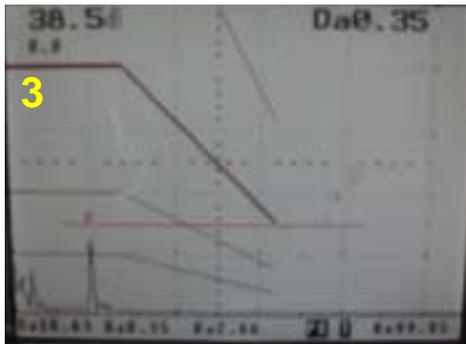
The A-Scan marked 3 shows a low level indication produced from the left side of the indication in picture 1. While A-Scan 4, shows a higher level indication produced from the right side of picture 1. If the extra 6dB of gain were removed, the indication in picture 3 would be 50% lower, and the same holds true for A-Scan 4. This reduction in sensitivity would make the indications below a Reject level.

The following A-Scans were digitally photographed, during manual prove up of this hole, as the supervisor wanted to know why the drilled hole was not detected by the UT system. The portable Flaw Detector was Standardized on a 3.2mm Hole, and produced a 100% indication. For the purposes of prove-up, 6dB of Gain is added, to make it easier for operators to find defects. The Reject DAC Gate was set for 80%, and plotted for various skip distances.
